ANNUAL REPORT FOR 2007

**Unnamed Tributary to Briery Run Mitigation Site
(Crescent Road Site)
Lenoir County
WBS Element 34501.4.1
TIP No. R-2719 WM**

Prepared By:
Natural Environment Unit & Roadside Environmental Unit
North Carolina Department of Transportation
December 2007

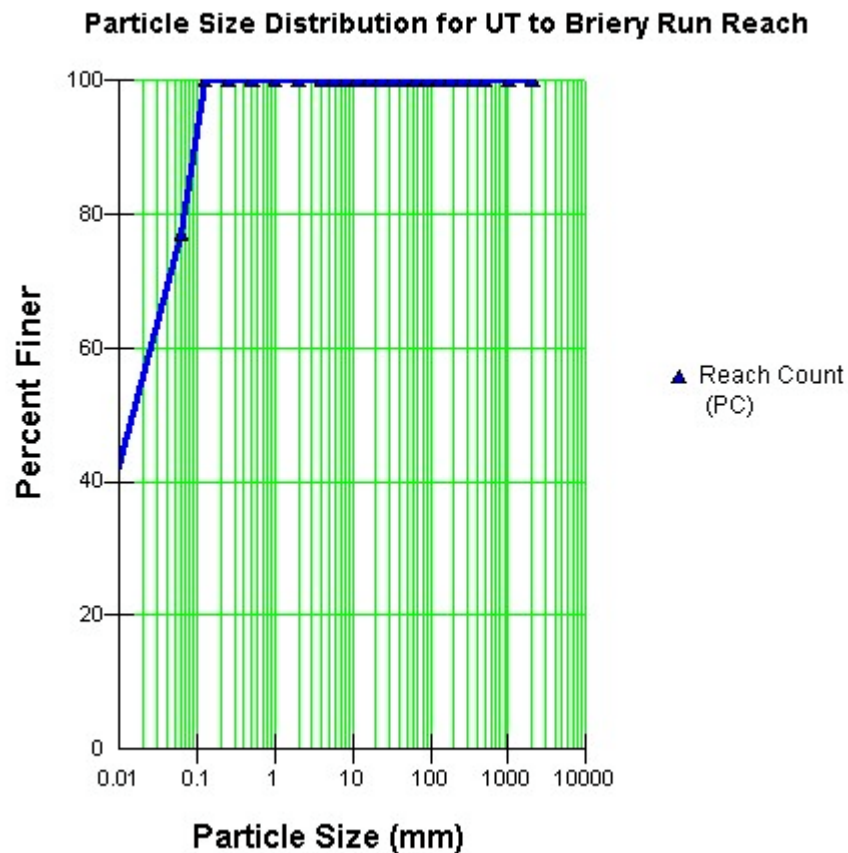
Chart 1. Particle Size Distribution for Reach 1 & 2

A representative pebble count was taken throughout the surveyed reach. This information is used to determine the stream type. Pre-construction data proposed the D_{50} for Crescent Road Mitigation Site to be 0.2 mm. The pebble counts taken during the Year 2007 monitoring period noted that the D_{50} (50 percent of the sampled population is equal to or finer than the representative particle diameter) for the entire reach of Crescent Road Mitigation Site was approximately 0.4 mm, which is indicative of a sand-bed stream.

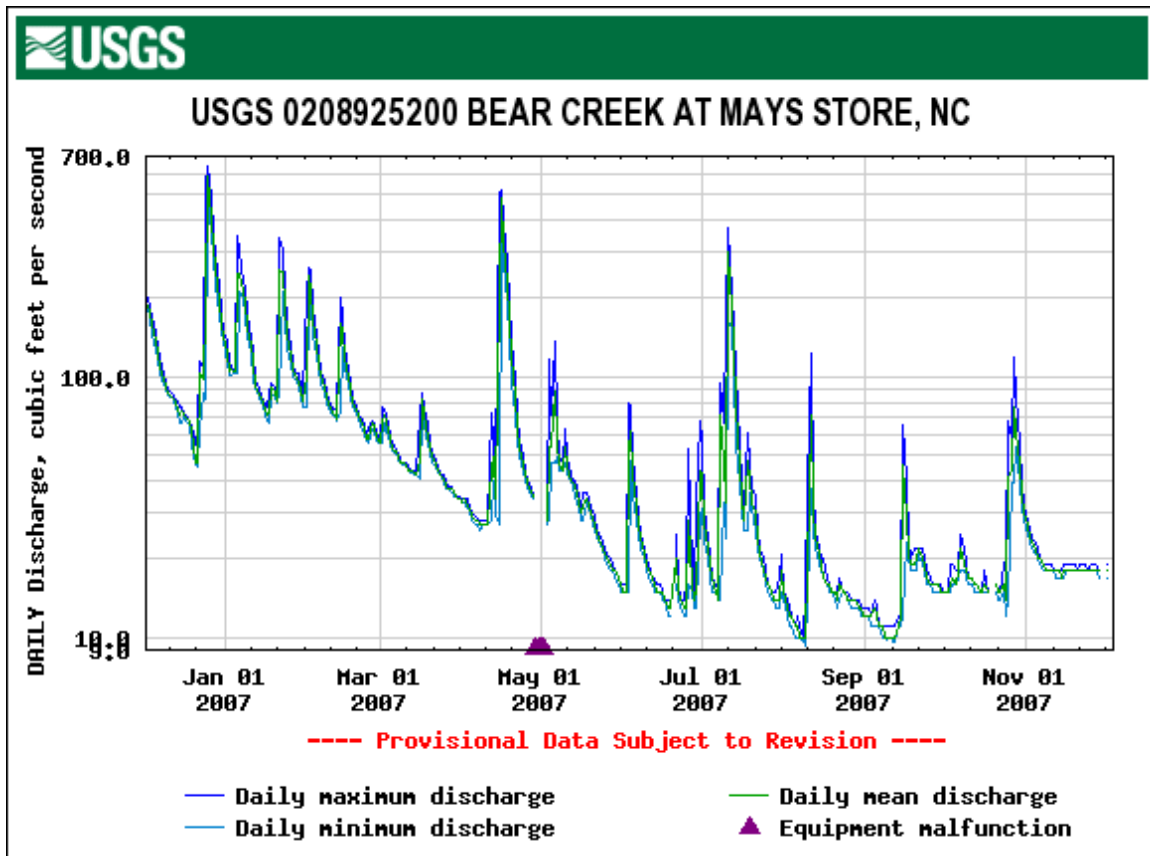
The Bear Creek gage was utilized for this report since it is the smaller of the two gages (57.7 square-mile drainage area as compared to the 2,692 square-mile drainage area associated with the Neuse River). The Bear Creek gage more accurately reflects hydrology and precipitation in the project area. It is situated in USGS Hydrologic Unit 03020202. Datum of the gage is 50 feet above sea level NGVD29. Based on the drainage area associated with the gage, the correlated bankfull discharge according to the NC Coastal Plain Regional Curves (USACE, 2003) is between 200 and 500 cubic feet per second (cfs). A review of peak flows was conducted for the period between January 2007 and November 2007. According to the graph, there were approximately six bankfull events documented during this monitoring period. This gage has met and exceeded the hydrological requirements in between 2001 and the current period. The USGS graphs depicting the peak flows occurring during 2007 is presented below.
